# HEARING EXAMINER EXHIBIT LIST

PROJECT:	Public Hearing for Preliminary Plat and Planned Residential
	Development for Belmont Terrace
FILE NUMBER(S):	PLPRD2019-01
APPLICANT:	CPH Consultants
HEARING DATE AND	July 16, 2019 at 3:00 PM
LOCATION:	Monroe City Hall Council Chambers
	806 West Main Street, Monroe, WA 98272

Public Hearing for Belmont Terrace Preliminary Plat and Planned Residential Development (PRD)

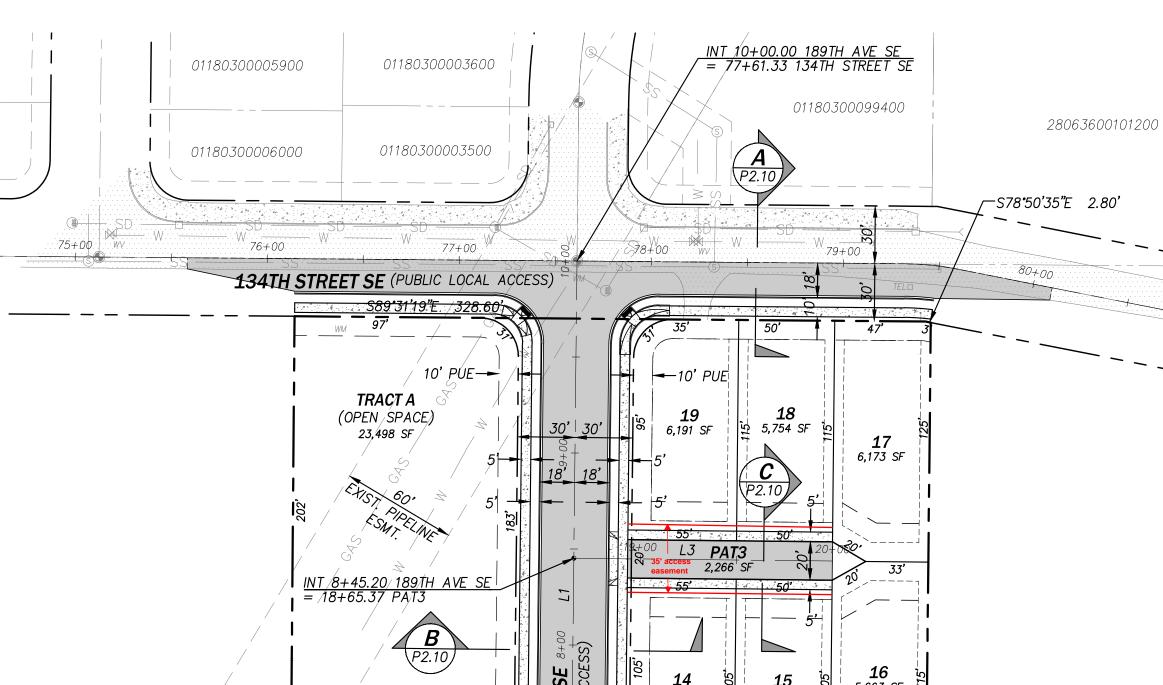
EACH PRIVATE ACCESS TRACT SHALL BE DESIGNATED AS A FIRE LANE AND INCLUDE APPROPRIATE SIGNAGE.

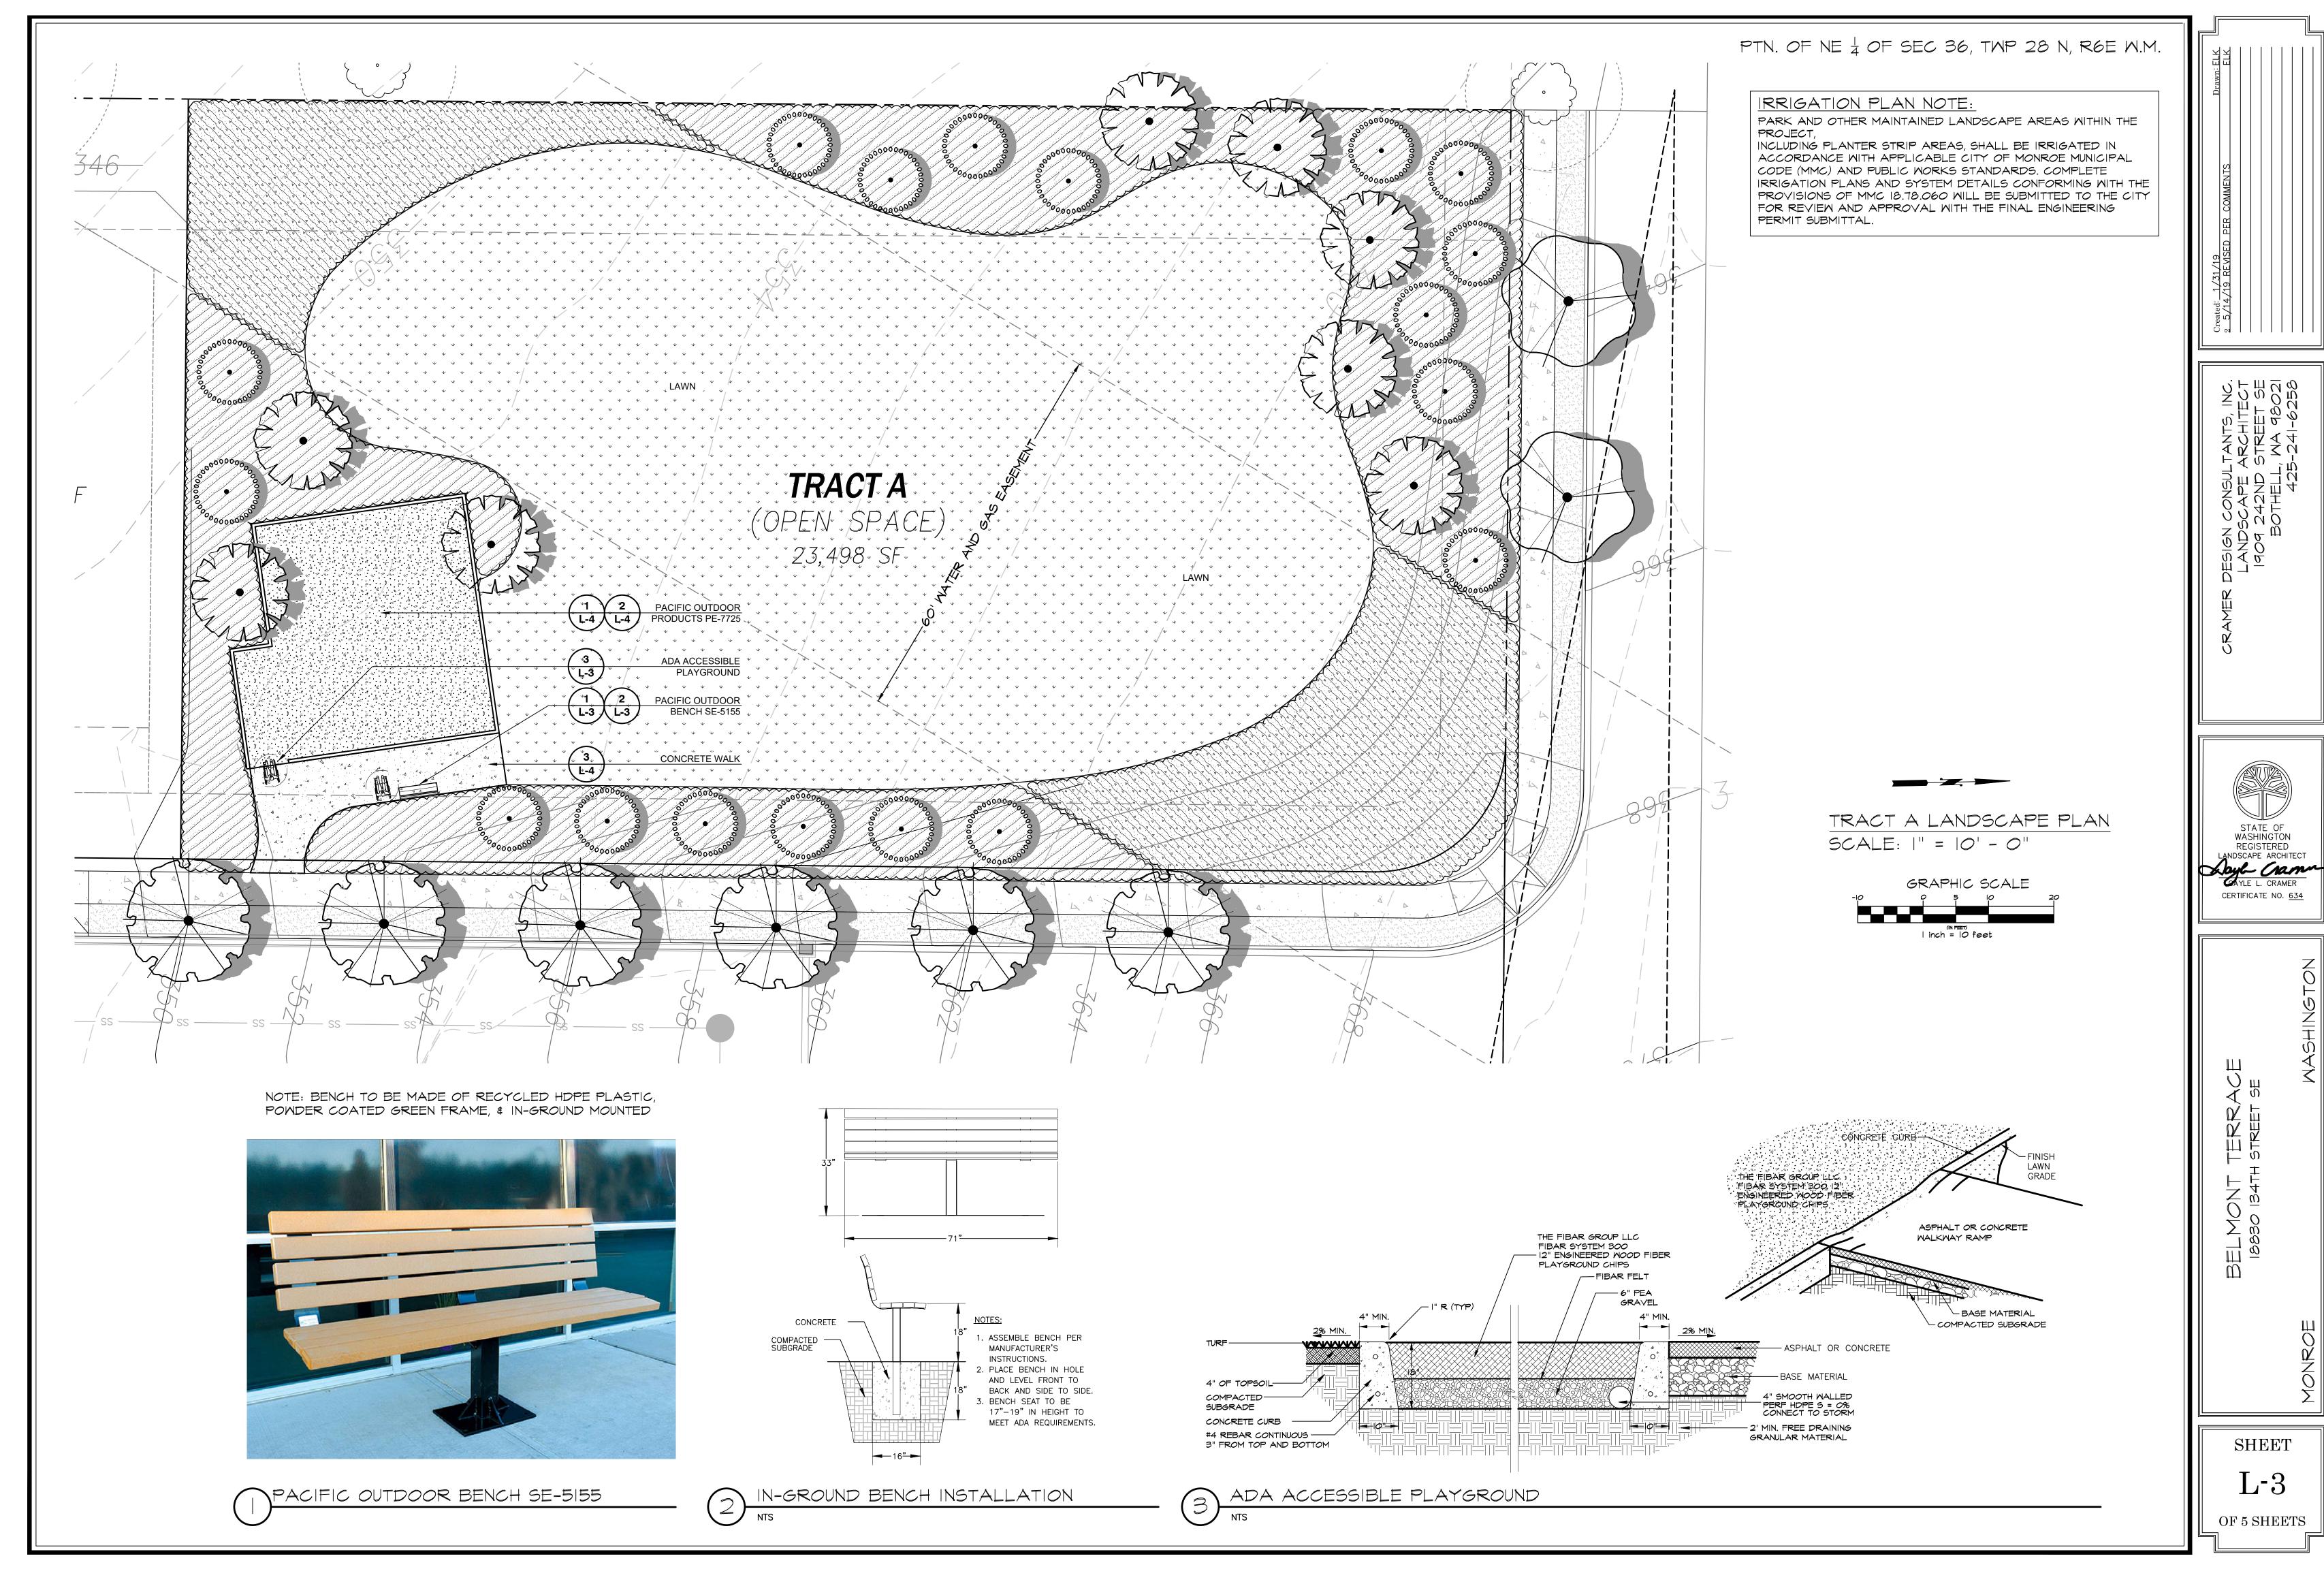
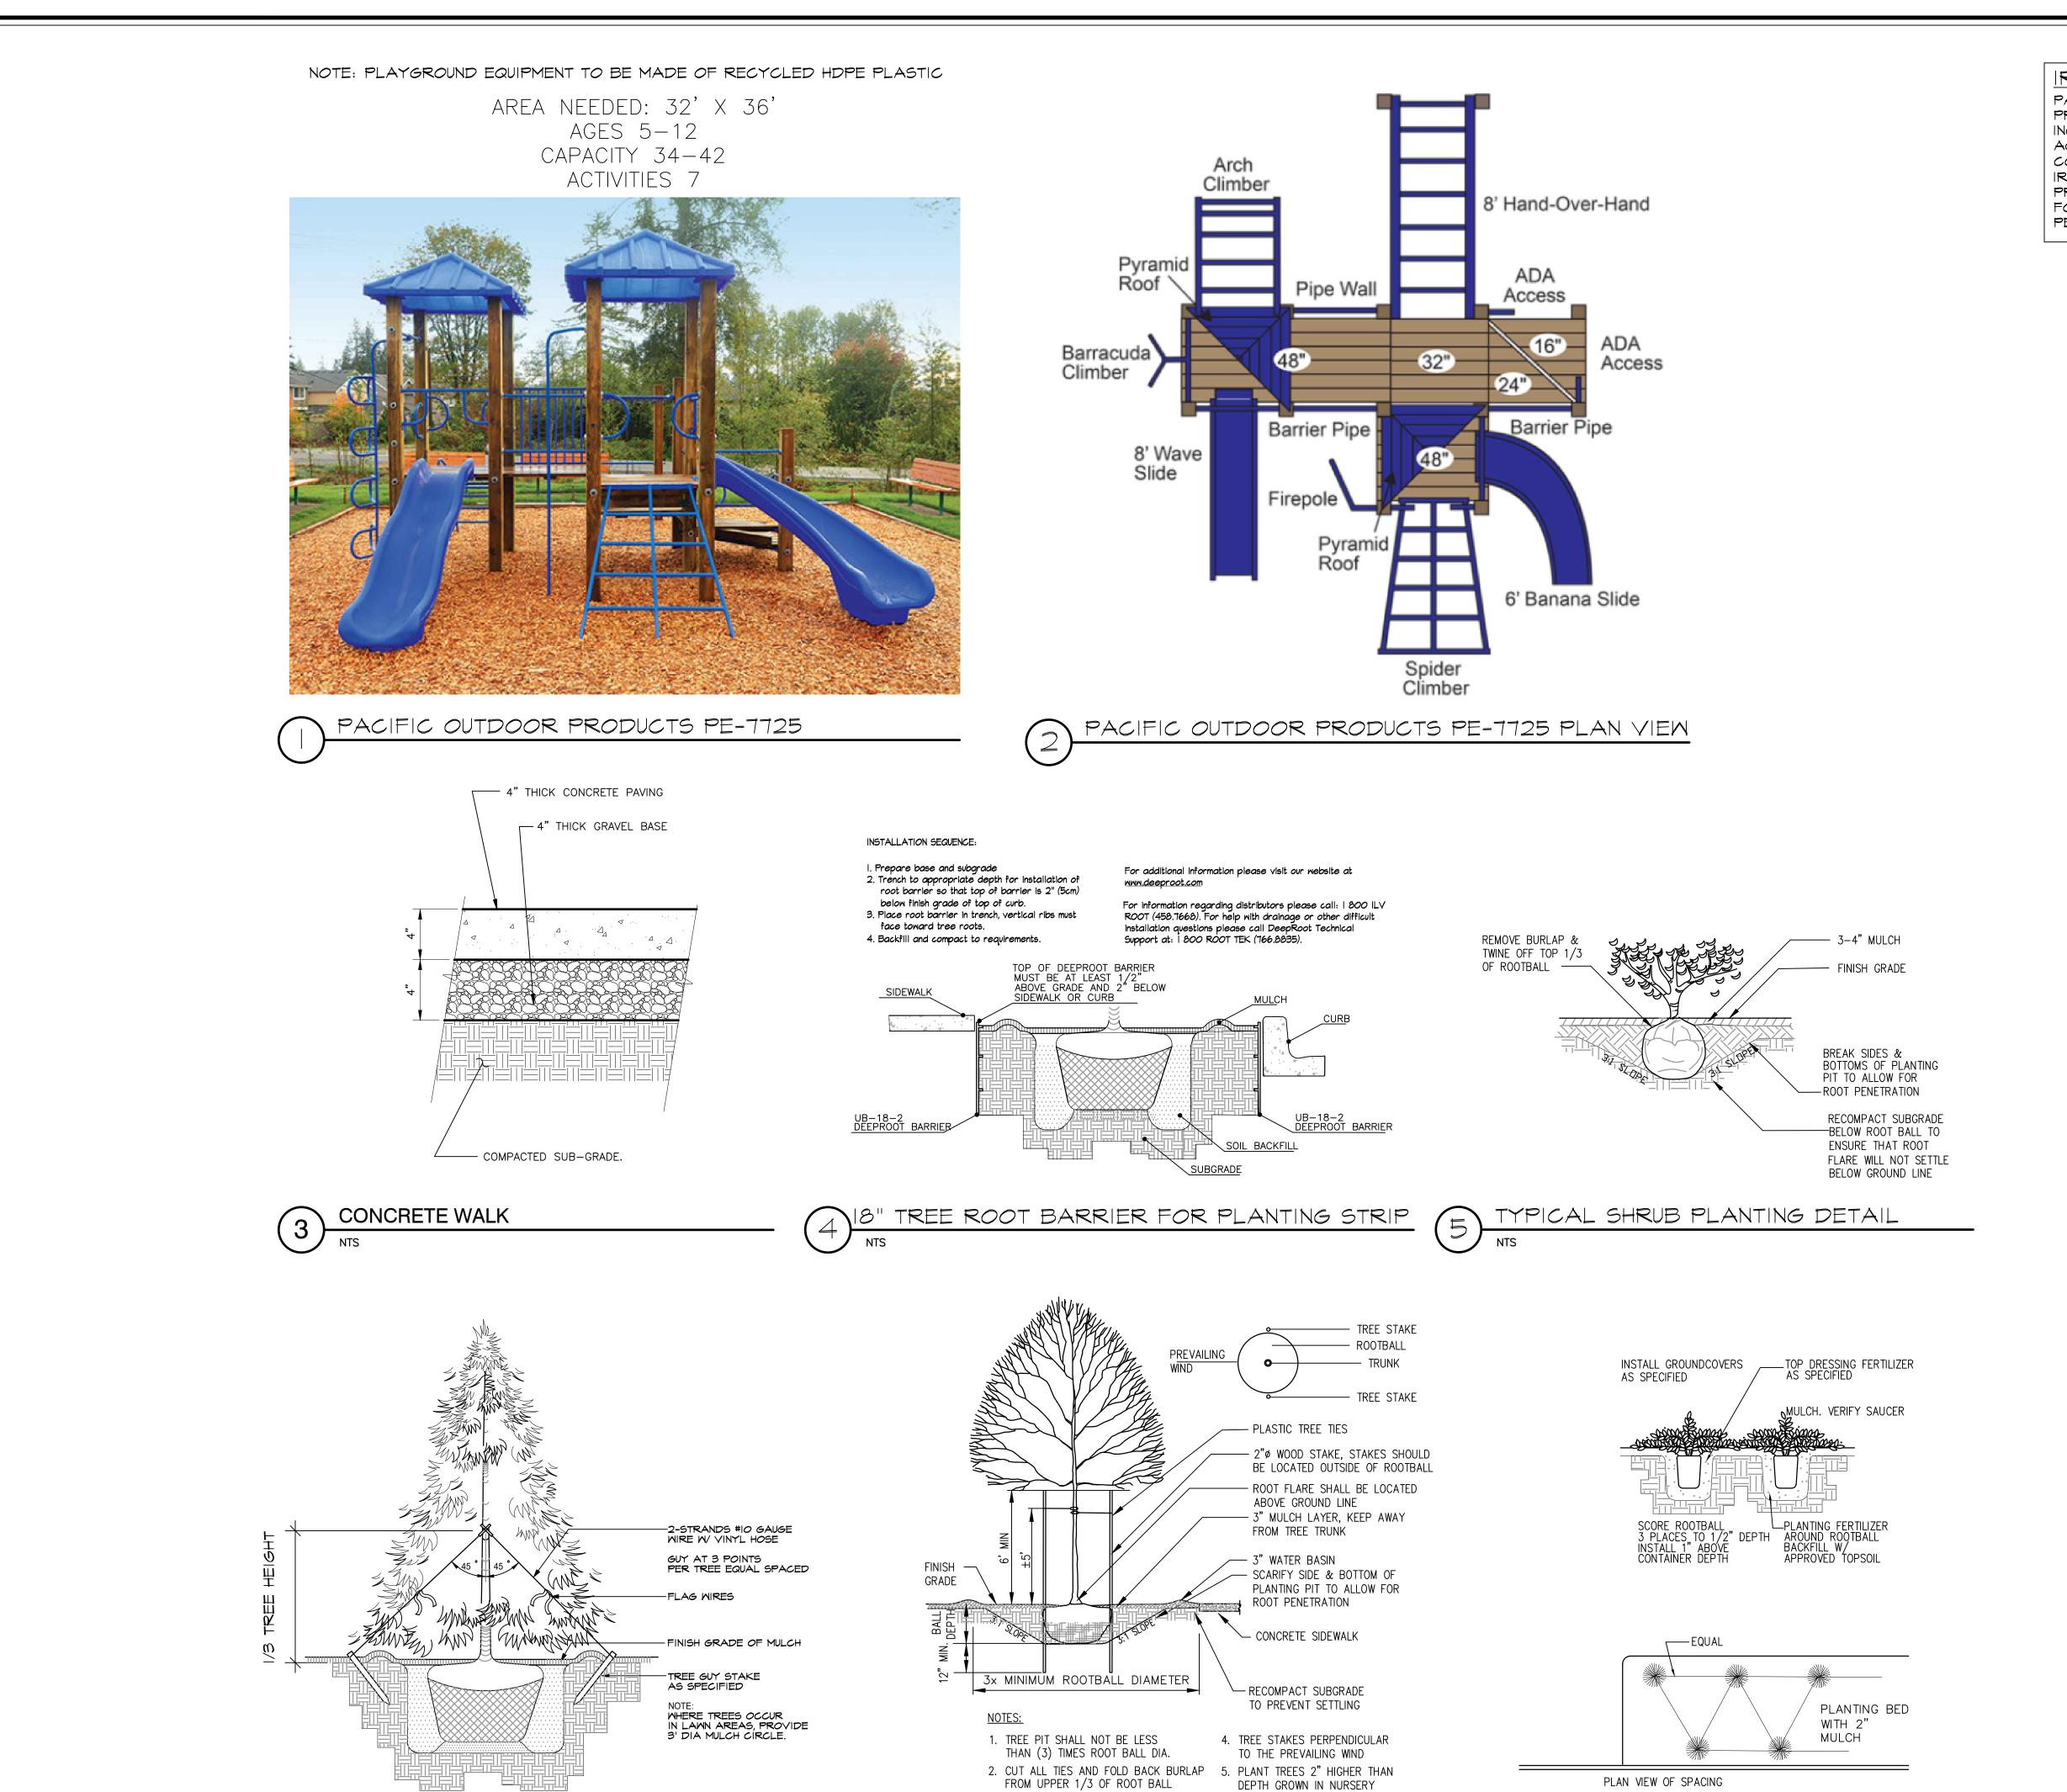
L-2

3. REMOVE ALL PLASTIC AND TWINE

TYPICAL DECIDUOUS TREE PLANTING DETAIL

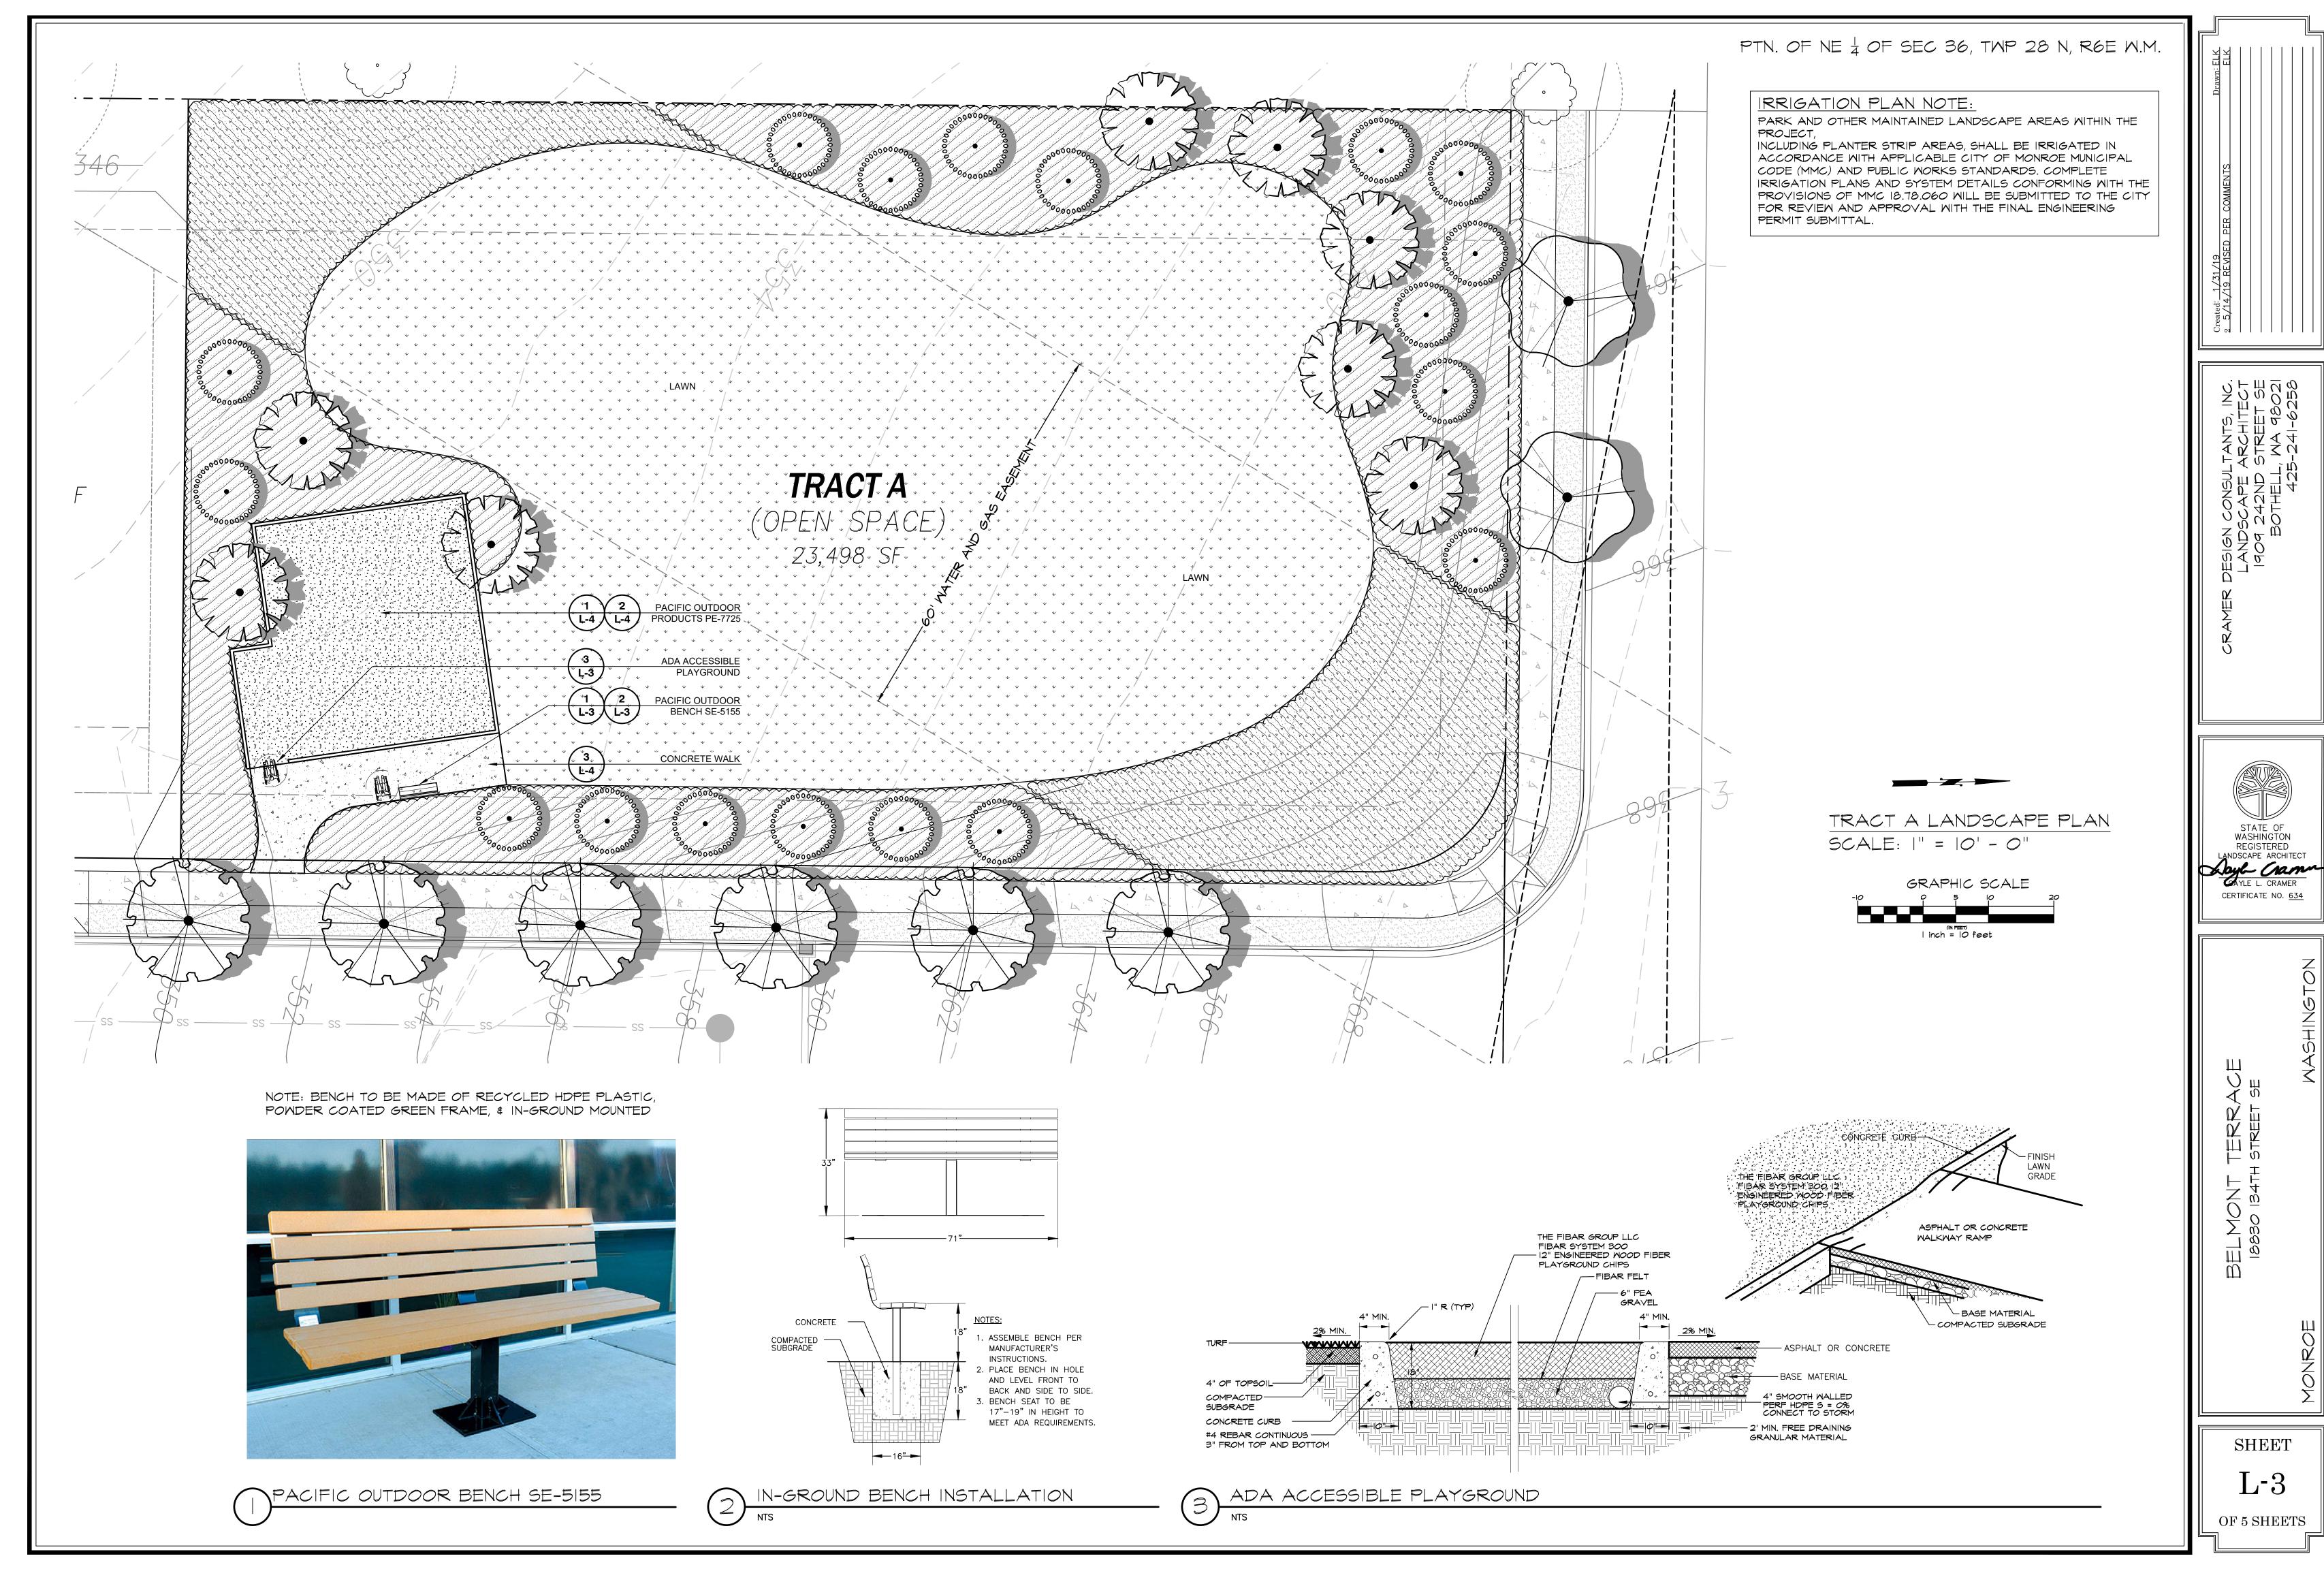
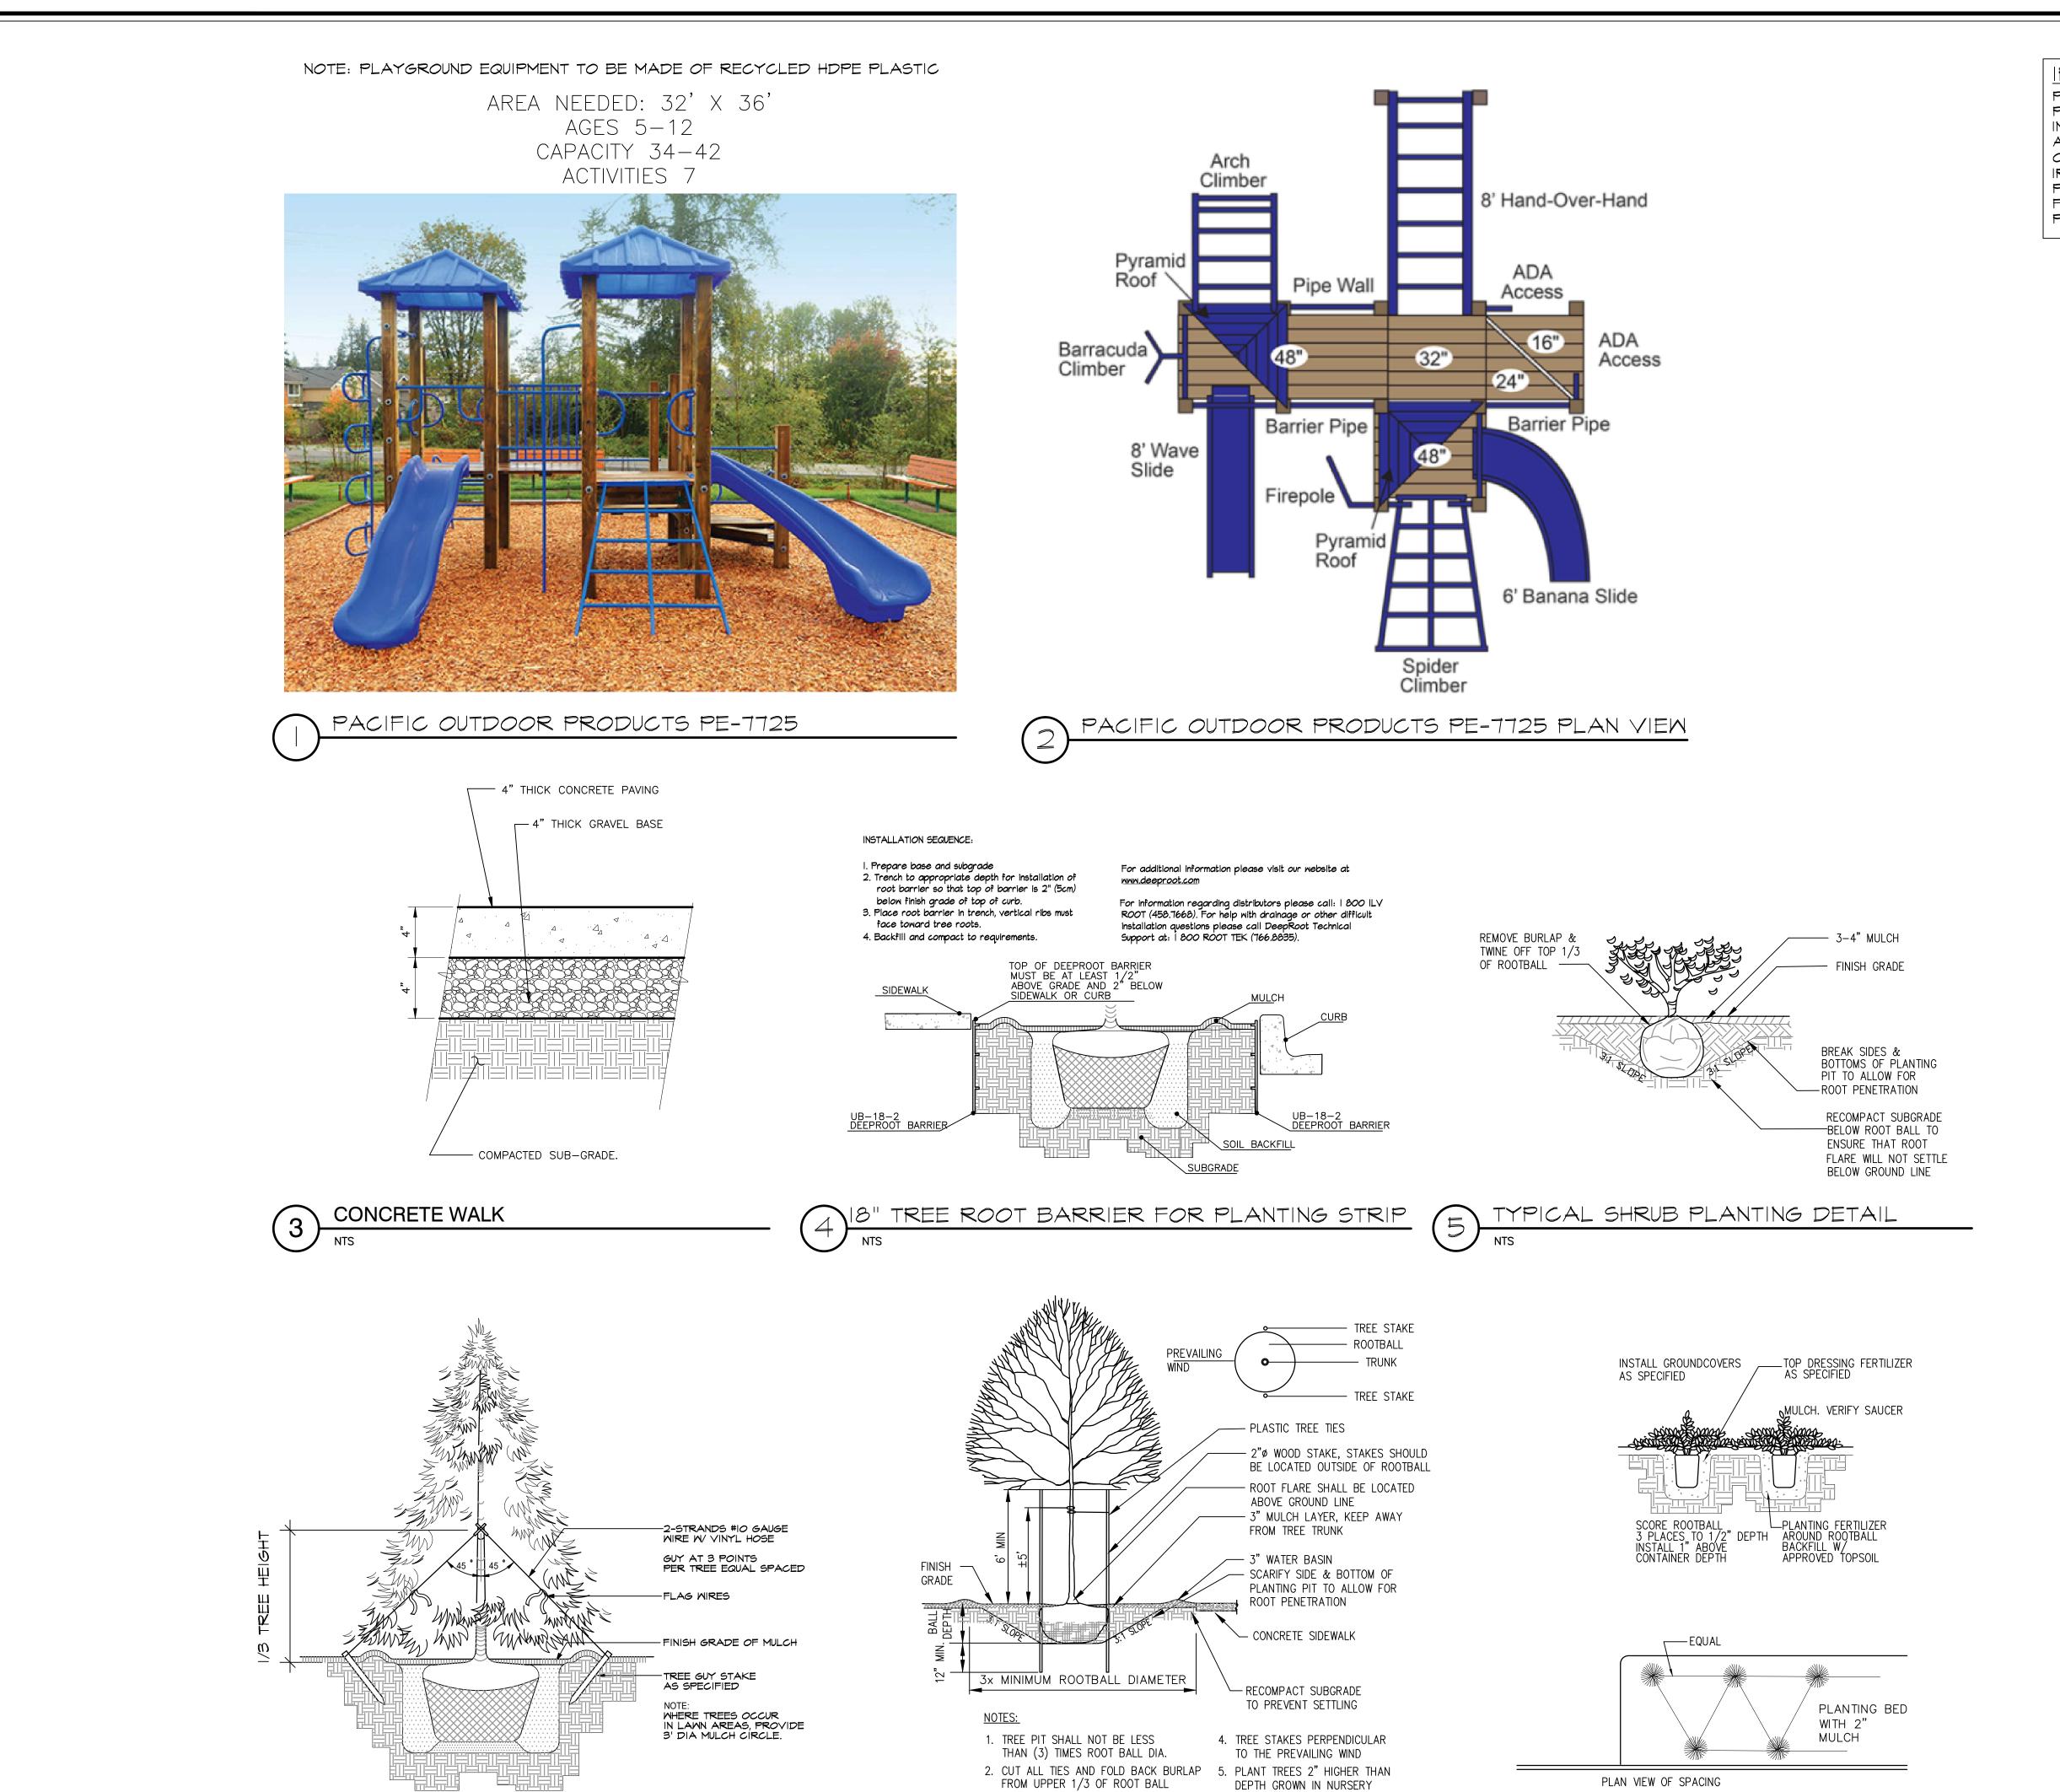
L-2

3. REMOVE ALL PLASTIC AND TWINE

TYPICAL DECIDUOUS TREE PLANTING DETAIL

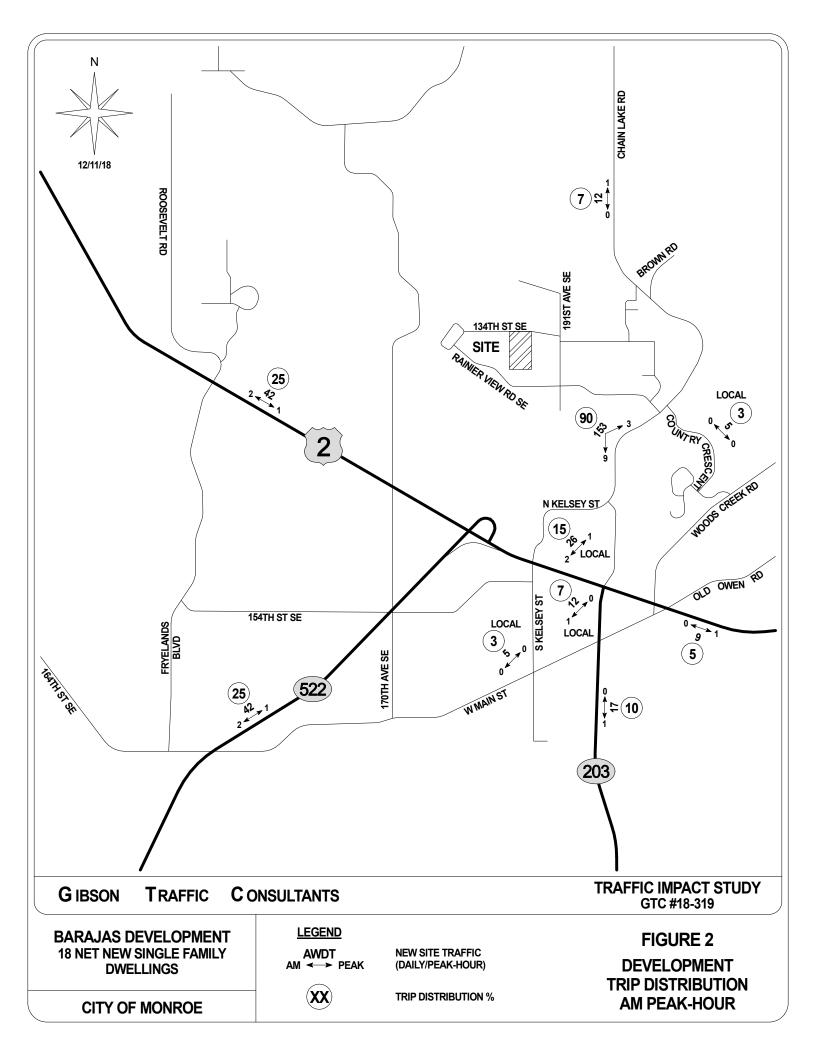
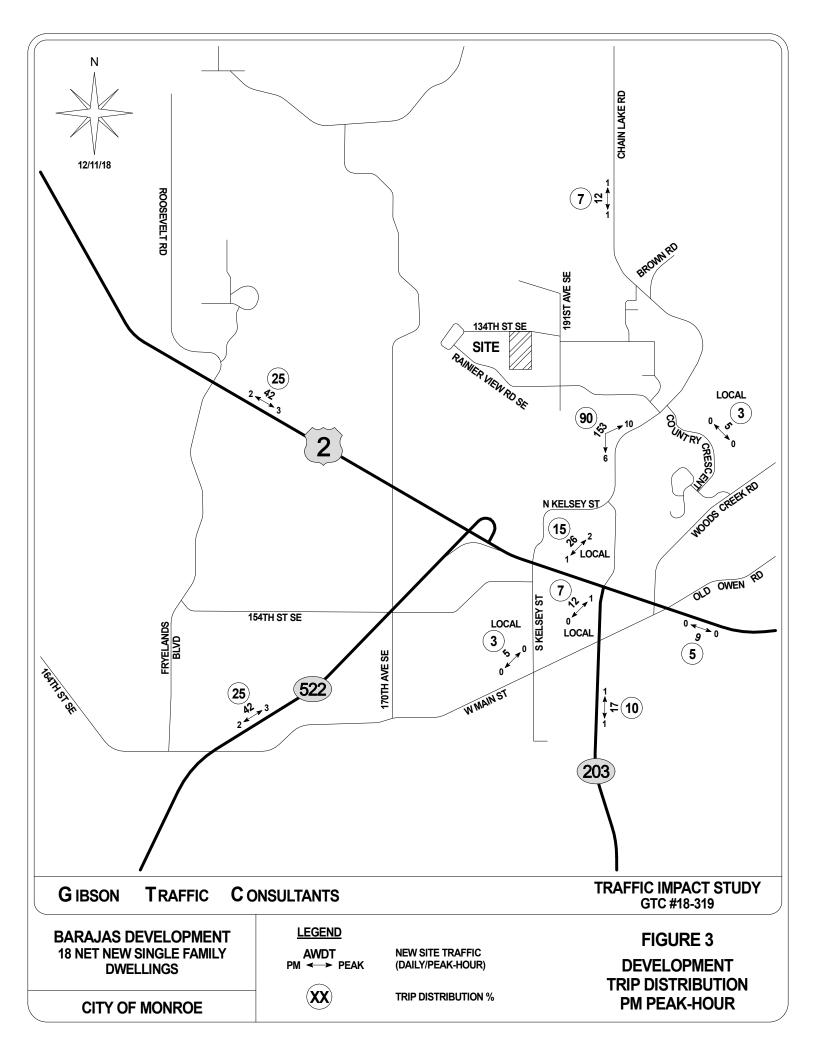
The distribution of trips generated by the Barajas development is based on approved distributions for developments in the site vicinity. It is anticipated that 25% of the development's trips will travel to and from the west along US-2. Approximately 35% of the development's trips will travel to and from the south, twenty-five percent along SR-522 and ten percent along SR-203. It is estimated that 28% of the development's trips will travel to and from local areas in the vicinity of the development, ten percent south of US-2, fifteen percent north of US-2, and three percent to the east. The remaining 12% of the development's trips are anticipated to travel to and from the north and east, seven percent to and from the north along Chain Lake Road and five percent to and from the east along US-2. Detailed distributions are included in Figure 2 for the AM peak-hour and Figure 3 for the PM peak-hour.

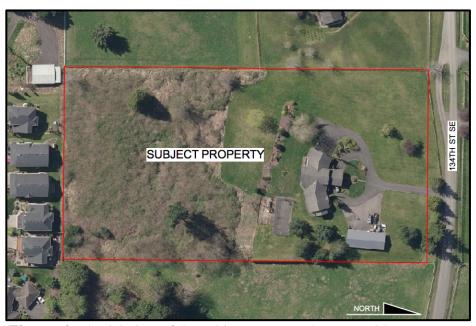
**Figure 1:** Aerial view of the subject property (not to scale)

The subject property is approximately 4.77-acres, located in an urban residential setting, south of the Snohomish County/City of Monroe border. The investigation area is currently developed in the north half of the site, with a single-family residence (SFR), garage, and associated infrastructure. Topography across the subject property generally slopes to the south. In the northern portion of the subject property, where the SFR is located, these slopes are more gradual (approximately 8 percent), becoming steeper (approximately 14 percent) in the southern region.
